# MICROSCOPIC EXAMINATION OF STEEL

HENRY FAY, Ph. D., D. Sc.

*Professor of Analytical Chemistry, Massachusetts Institute of Technology  
Consulting Metallurgist, Watertown Arsenal*

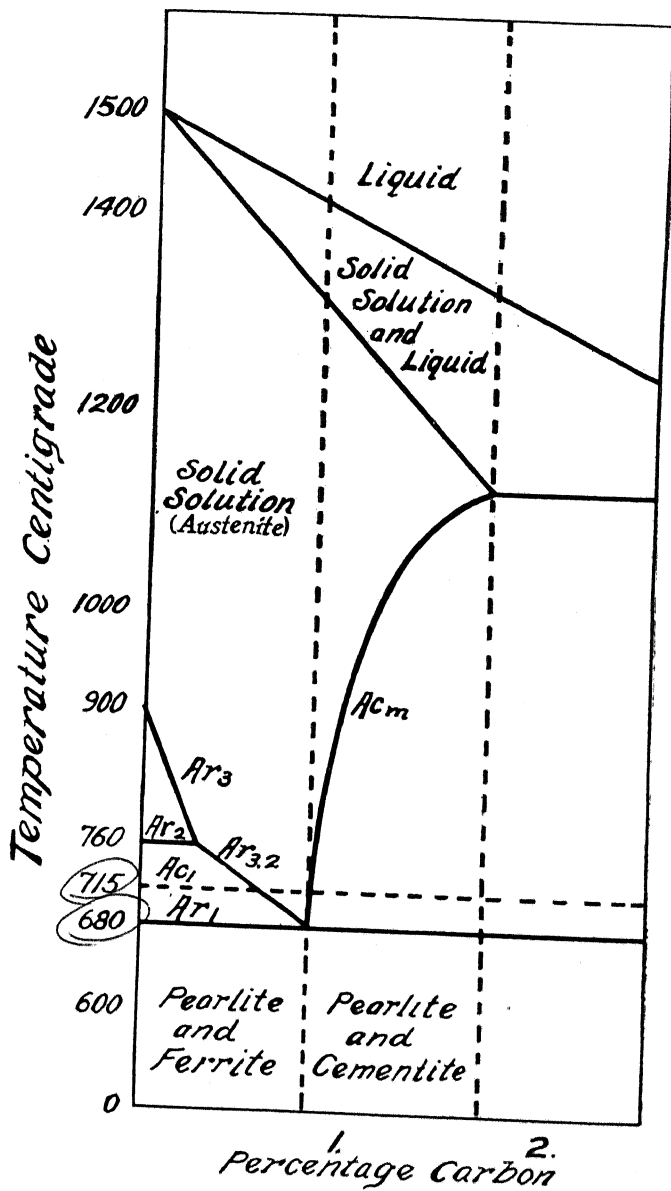
Fig. 1

Portion of iron-carbon diagram

constituents, iron and iron carbide. The  $A_{c1}$  point is approximately  $30^\circ$  higher than the  $A_{r1}$  point, and represents the beginning of the formation of solid solution. In steels containing 0.85 per cent carbon there is but one critical temperature at which the solid solution decomposes into its constituents, iron and iron carbide. This is known as an eutectoid steel, and its microscopic constituent is pearlite. Pearlite always etches dark, and under high magnifications is shown to consist of alternate laminations of iron and iron carbide. Steels containing less than 0.85 per cent carbon are hypoeutectoid, and contain the microscopic constituents ferrite and pearlite, the amount of the latter increasing with the per cent of carbon. Steels containing more than 0.85 per cent carbon are hypereutectoid, and contain the microscopic constituents cementite (iron carbide,  $Fe_3C$ ) and pearlite. These facts are illustrated in the diagram. (Fig. 1.)

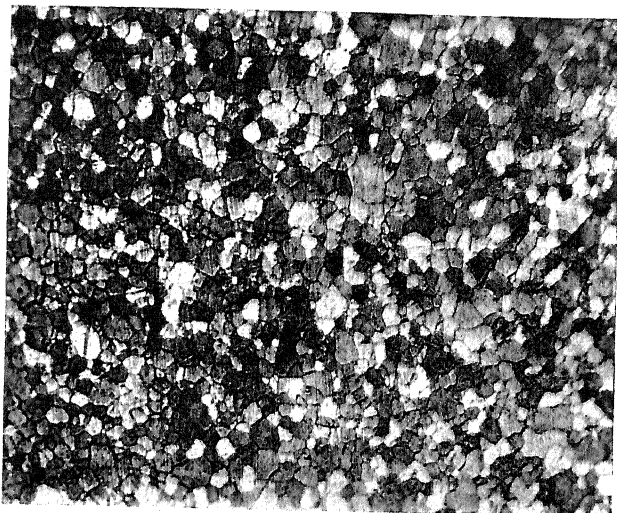
PHOTOGRAPH NO. 1. X75.  
0.06% carbon. Approximately pure ferrite.

Photograph No. 1 shows the characteristics of a carbonless iron in which the whole field is made up of granules of ferrite. With the introduction of carbon there is a decrease in the amount of ferrite and the constituent pearlite begins to appear. This is shown in photograph No. 2 for a steel containing 0.18 per cent carbon. Inasmuch as steels containing 0.85 per cent carbon contain 100 per cent pearlite, and as pearlite is composed of ferrite and cementite, in this steel containing 0.18 per cent carbon there ought to be approximately 20 per cent of the field made up of pearlite. In a steel containing 0.5 per cent carbon there should be 58.8 per cent pearlite. Such a steel is shown in photograph No. 4. A eutectoid steel containing 0.83 per cent carbon and practically 100 per cent pearlite is shown in photograph No. 7. Under higher magnifications pearlite shows the laminated structure shown in photograph No. 8. In hypereutectoid steels the excess carbon beyond that necessary to form pearlite, separates as free cementite and the amount of free cementite can be calculated. Inasmuch as the whole field is made up of pearlite

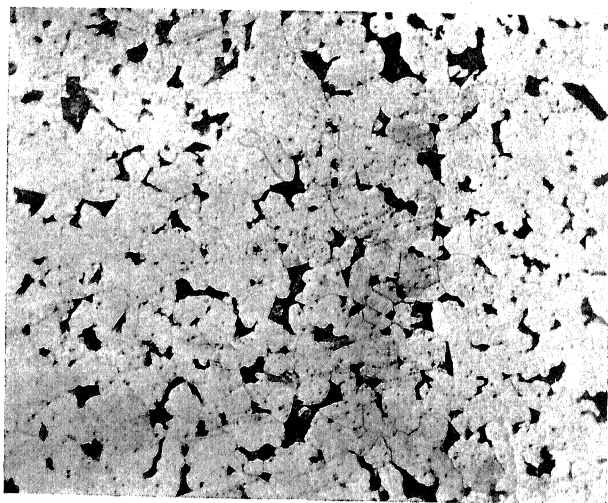
PHOTOGRAPH NO. 2. X75.  
0.18% carbon. Ferrite (white) and pearlite (dark).

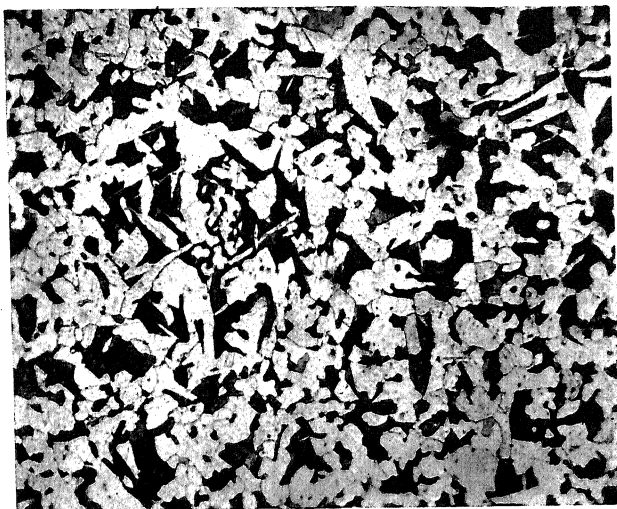
PHOTOGRAPH NO. 3. X75.

0.32% carbon. Ferrite (white) and pearlite (dark).

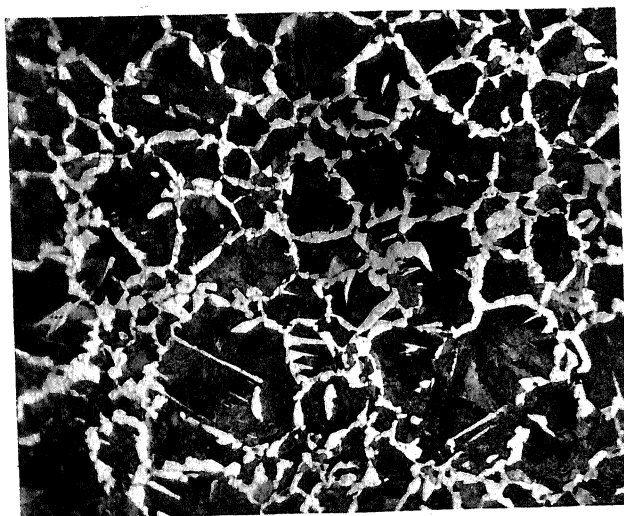
PHOTOGRAPH NO. 4. X75.

0.49% carbon. Ferrite (white) and pearlite (dark).

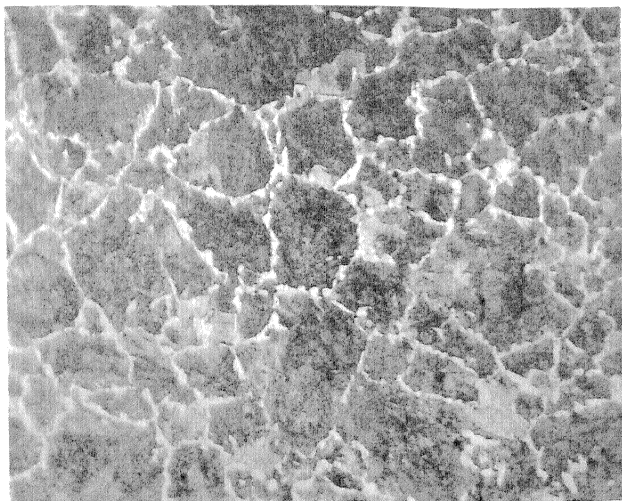
PHOTOGRAPH NO. 5. X75.  
0.57% carbon. Ferrite and pearlite.

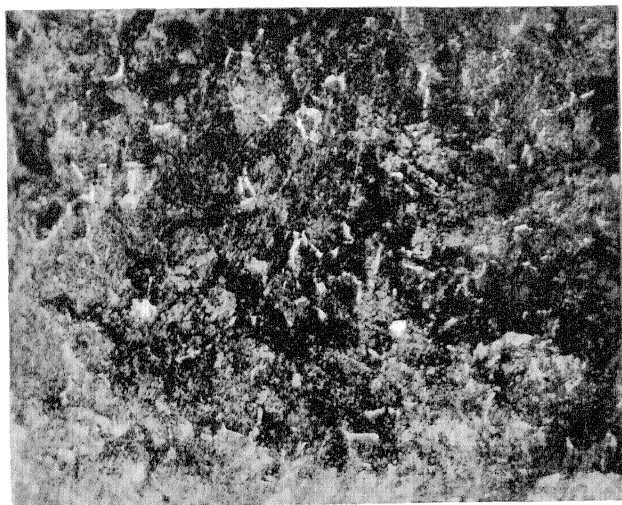
PHOTOGRAPH NO. 6. X75.  
0.71% carbon. Ferrite and pearlite.

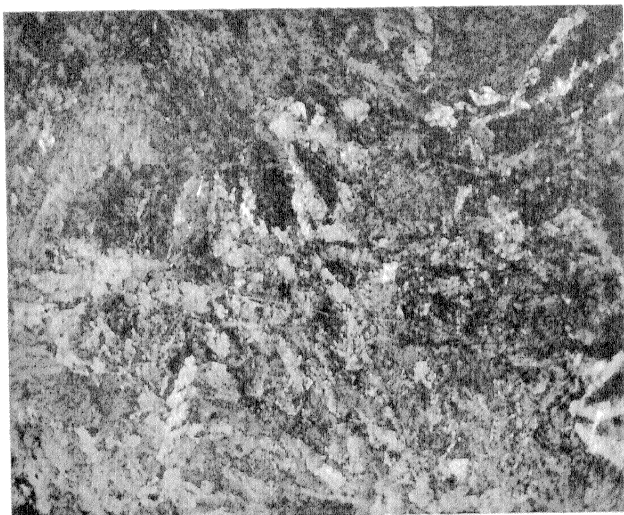
PHOTOGRAPH NO. 7. X75.

0.83% carbon. Pearlite.

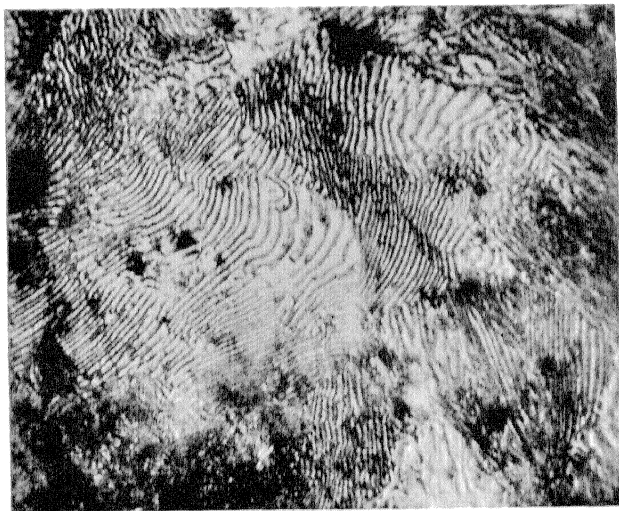
PHOTOGRAPH NO. 8. X485.

0.83% carbon. Pearlite.

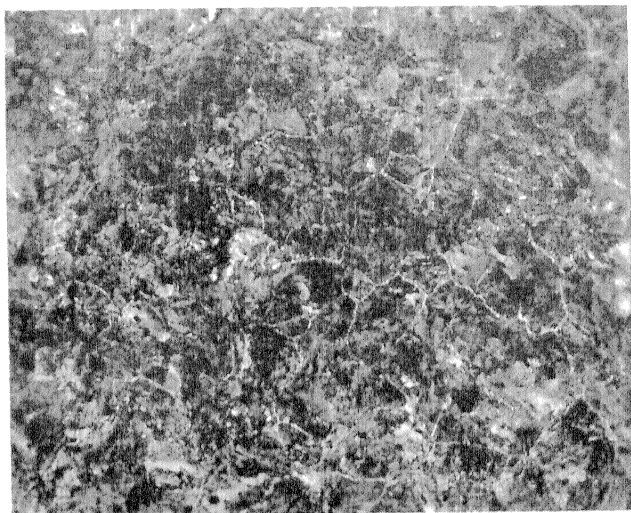
PHOTOGRAPH NO. 9. X75.

1.22% carbon. Pearlite and cementite (white).

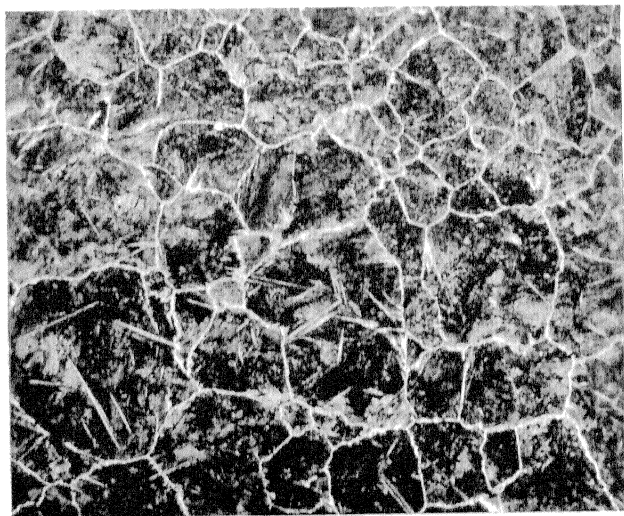
PHOTOGRAPH NO. 10. X75.

1.46% carbon. Pearlite and cementite (white).

and cementite and it requires 0.85 per cent of the carbon to form the pearlite, the difference between the total carbon and 0.85 per cent carbon gives the amount of carbon available to form cementite. Thus in a steel containing 1.25 per cent carbon there is available for cementite formation 0.4 per cent carbon and as cementite,  $\text{Fe}_3\text{C}$ , contains 6.67 per cent carbon the 0.4 per cent carbon would furnish approximately 6 per cent cementite which would occur in the free state, and the steel would contain 94 per cent of pearlite and 6 per cent cementite. See photograph No. 9. It is thus evident that by microscopic examination a rough determination of carbon may be made on *slowly* cooled steels. Photograph No. 10 shows a steel containing 1.46 per cent carbon — approximately 9 per cent cementite — in which the white constituent is cementite.

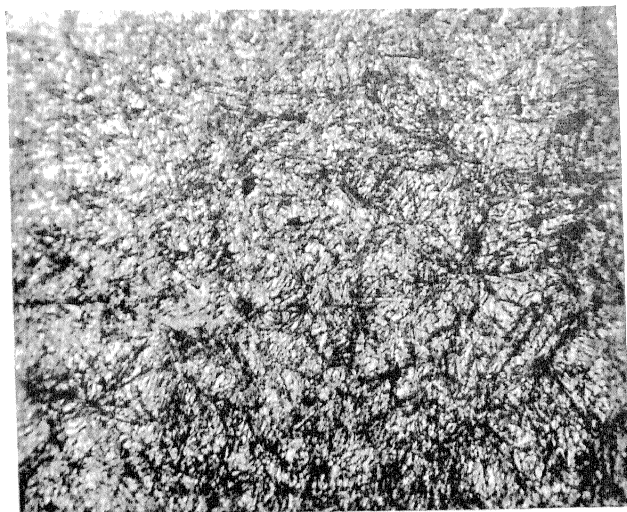
PHOTOGRAPH NO. II. X75.

Martensite.

Photograph No. 11 shows the characteristic appearance. Commercially martensitic steels are unimportant on account of their extreme brittleness and they are found only rarely.

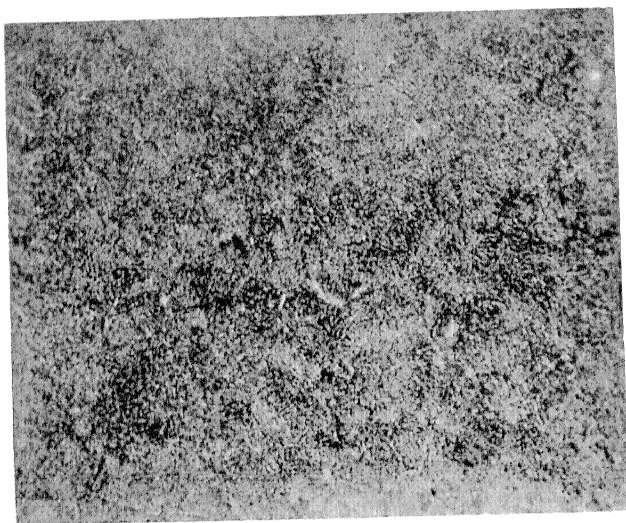
PHOTOGRAPH NO. I2. X75.

Troostite.

If heated to temperatures below  $A_{c1}$ , the effect produced will vary with the temperature. The lower the temperature of reheating the smaller is the tendency toward stable equilibrium; the higher the temperature the more stable is the product produced. Practically any degree of hardness may be produced, varying from glass-hard to extreme softness, by properly regulating the temperature of the heating. There are then two extremes, the martensitic steels formed by quenching from above  $A_{c1}$  and the pearlitic steels formed by cooling slowly from  $A_{r1}$  or above. Intermediate between these extremes are steels in which more or less of the unstable solid solution has been partly converted to more stable forms. Such forms are represented microscopically by troostite and sorbite. Troostite, formed by tempering at relatively low temperatures, represents the first stage in the breaking down of the unstable equilibrium and is characterized by the amorphous or slightly granular structure. On etching with alcoholic nitric acid the surface usually blackens immediately from separated carbon. Photograph No. 12 shows troostite.

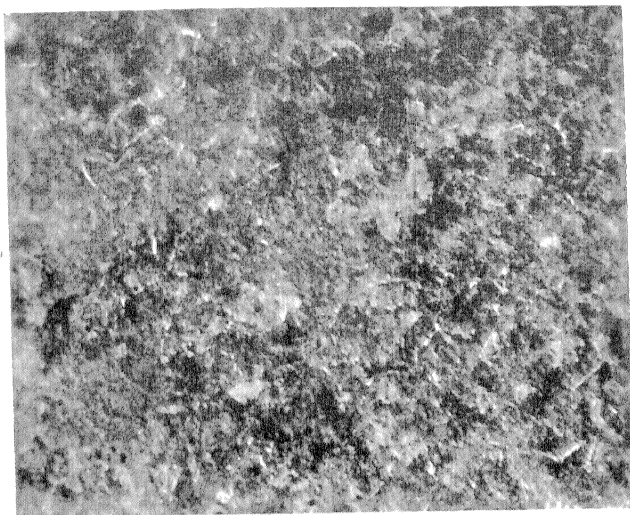
PHOTOGRAPH NO. 13. X75.  
Sorbite.

Sorbite steels are those which have been quenched and heated to a higher temperature and thus represent a more stable state of equilibrium. They are characterized by having a peculiar grayish color, and the structure is better defined than troostite. The particles of iron carbide have not assumed definite laminations with ferrite as in pearlite, but are very much more distinct than in troostite. Photograph No. 13 shows sorbite.

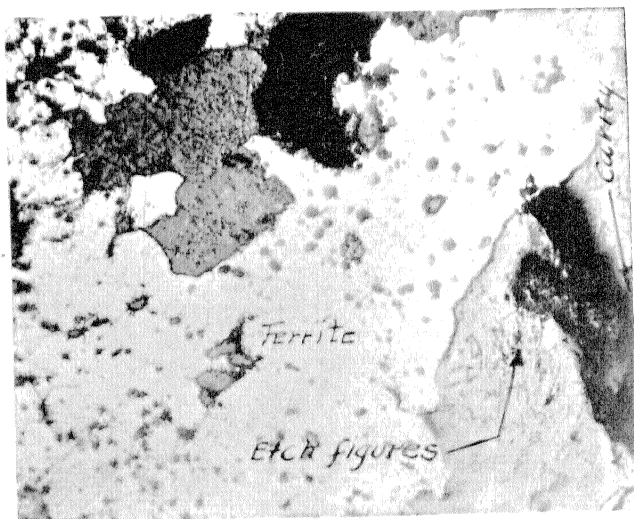
PHOTOGRAPH NO. 14. X50.  
Ferrite and massive silicate of manganese. Etch figures in the silicate. (Ferrite, white; silicate, dark.)

It is difficult at times to distinguish readily between silicate and sulphide of manganese without resort to special tests. They both occur as dove-colored constituents and are best observed on the polished but unetched surface. See photographs Nos. 17 and 18. The former, especially if occurring in masses, will frequently show crystalline etch figures. See photographs Nos. 14 and 15. In slowly cooled, unworked steel they will show as rounded dove-colored masses usually in the ferrite; in forged steels they are elongated in the direction of forging. See photographs Nos. 16 and 17. Inasmuch as all steels contain some slag, it is a matter of opinion as to how much should be allowed. The form in which it occurs is of greater importance than the actual amount present, although the smaller the amount of slag the better the product. It is especially undesirable to have the slag in masses, and particularly in elongated streaks. It then produces ghost lines and is usually accompanied by streaks of ferrite which are usually further embrittled by the presence of high phosphorus. Such slag streaks are frequently the source of cracks which develop along the slag in the direction of forging.

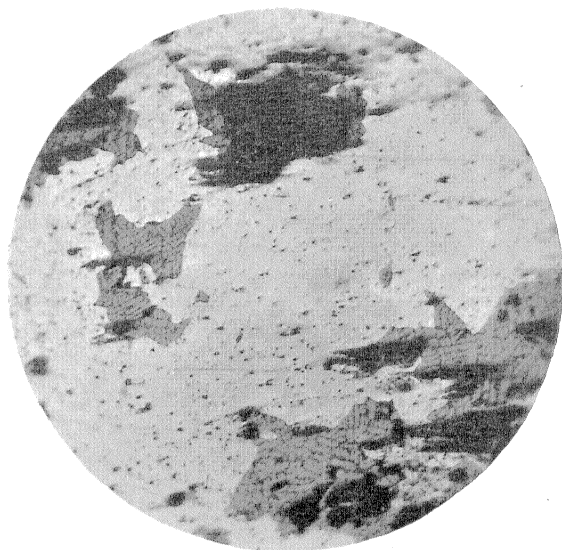
PHOTOGRAPH NO. 15. X50.

Etch figures in silicate of manganese, and cavities due to removal of silicate.

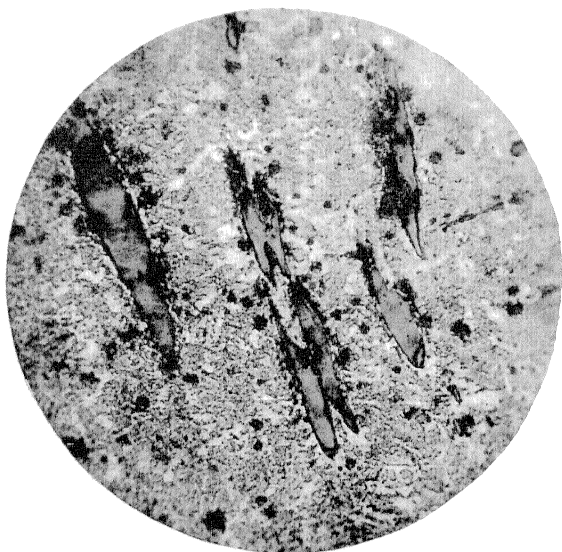
PHOTOGRAPH NO. 16. X50.

Sulphide of manganese in gun steel.

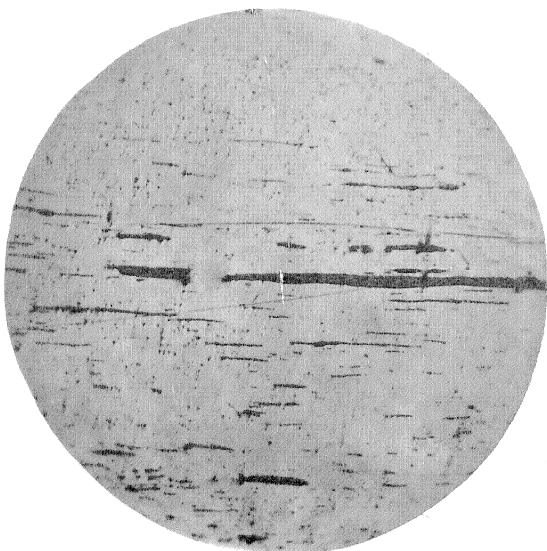
PHOTOGRAPH NO. 17. X50.

Slag elongated in direction of forging. Specimen unetched.

By reference to photographs Nos. 14 to 18 may be seen some of the forms in which slag may occur, and other examples may be seen under the discussion of special cases.

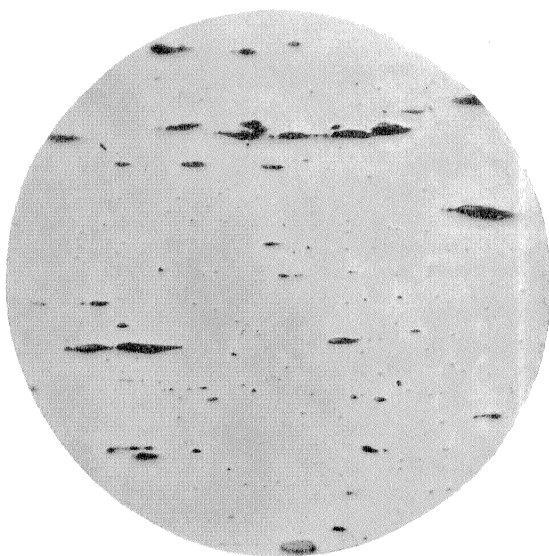
PHOTOGRAPH NO. 18. X50.

Unevenly distributed slag. Specimen unetched.

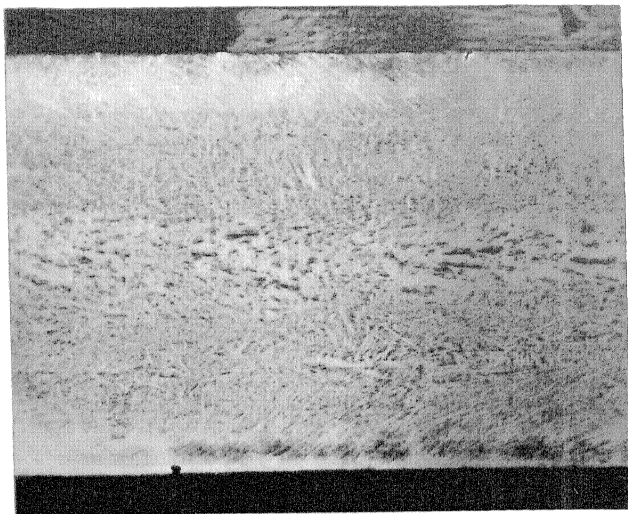
PHOTOGRAPH NO. 19. ONE-THIRD SIZE.  
Ingot structure in steel.

The presence of ingot structure such as shown in photograph No. 19 indicates that the heat treatment and forging have not been sufficient to wipe out the crystallization which occurred on the solidification of the metal. It is not definitely known that the presence of ingot structure is harmful, and it is frequently accompanied by excellent microstructure, but it serves as an indication of the heat treatment to which the metal has been subjected after solidification. It is believed that such a structure would not be found in the best steel, and it is further believed that metal showing ingot structure would be more liable to rupture from shock than metal in which the ingot structure had been wiped out by heat treatment and forging.

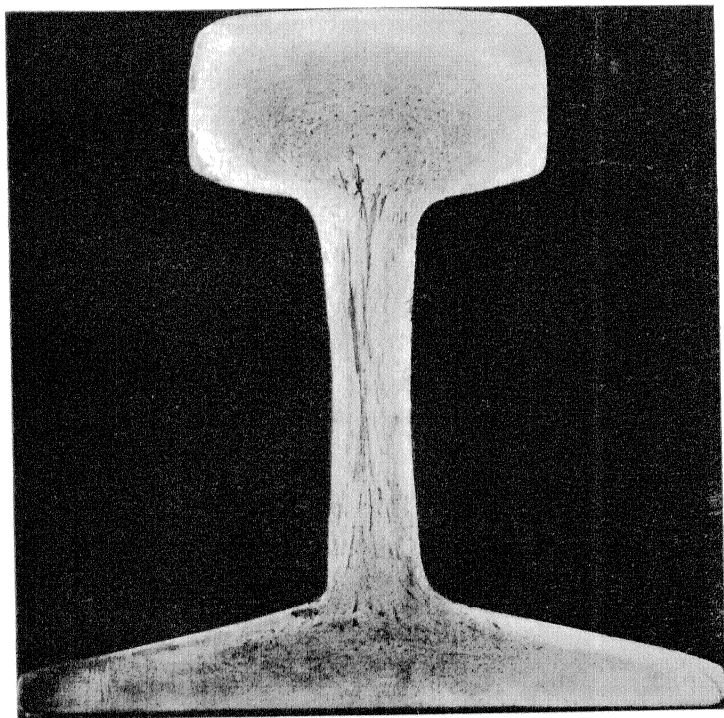
PHOTOGRAPH NO. 20.  
Cross section of steel rail showing segregation in center of head, web, and base.

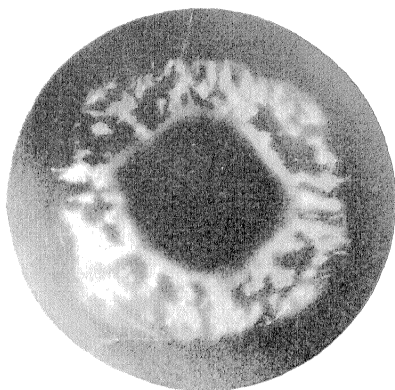
PHOTOGRAPH NO. 21.

Segregation of phosphorus in cold-rolled shafting.  
Etched with iodine. (White areas.)

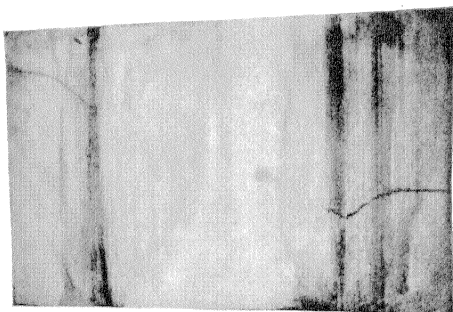
PHOTOGRAPH NO. 22.

Cross section of No. 21. Etched with nitric acid.  
(Dark streaks.)

in which segregation of phosphorus is shown. Photograph No. 22 shows a longitudinal section of the same piece of shafting and is etched with nitric acid, which darkens the phosphide areas. It is seldom possible, however, to obtain complete cross sections, but valuable indications may be obtained from surface structures or from test-bar sections, such as shown in photograph No. 38 of test bars marked 2, 3, and 5. The phenomena observed here will be more fully discussed later.

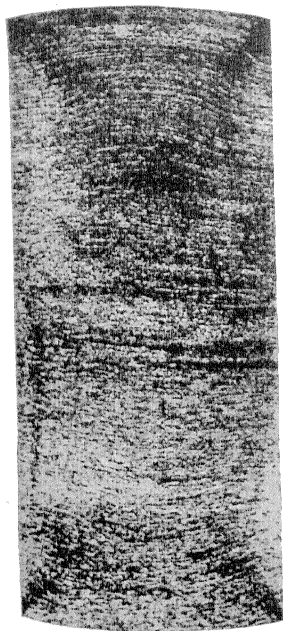
PHOTOGRAPH NO. 23.

Area of strained metal brought out by etching with copper ammonium chloride.

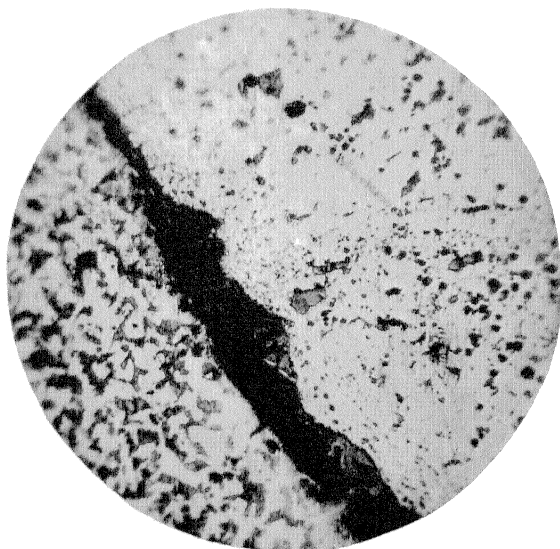
PHOTOGRAPH NO. 24. X50.

Crack, slag, and decarbonized area found on the base of a steel rail.

The inclusion of oxide is frequently accompanied by partial decarbonization, and is most frequently found on or near the surface. An example of this is shown in photograph No. 24, in which it is seen that a crack has penetrated through the slag, probably mill scale, and in the crack are the remnants of the slag. On the left of the crack is the normal structure and on the right is a decarbonized area containing slag. Such an area would probably be large enough to show to the naked eye and would be considered unsafe. Other examples of oxide inclosures are cited on pages 14 and 15, in the discussion of the failure of 10-inch gun and 14-inch gun lever.

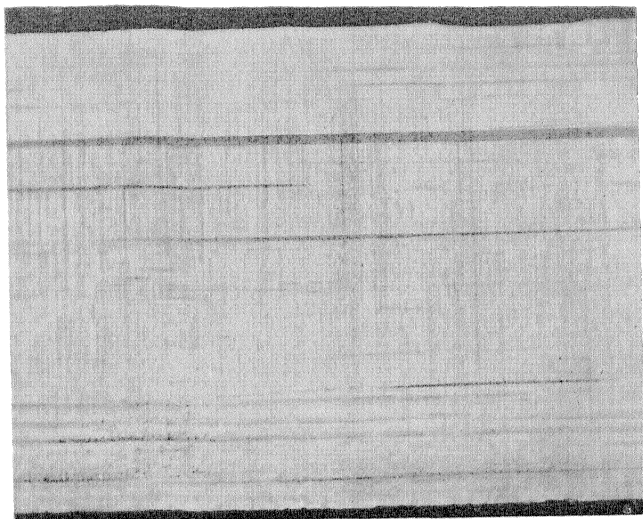
PHOTOGRAPH NO. 25.  
Dark streaks in steel rail.

Radial test pieces from gun forgings will frequently show streaks, and as the tension is normal to the direction of extension the specimen will show low ductility. Photographs Nos. 25 and 26 show, respectively, dark and light streaks, and photograph No. 27 shows the microstructure of a portion of the light-colored streak with its decarbonization and accompanying slag. (See also Tests of Metals for 1909, vol. 11.)

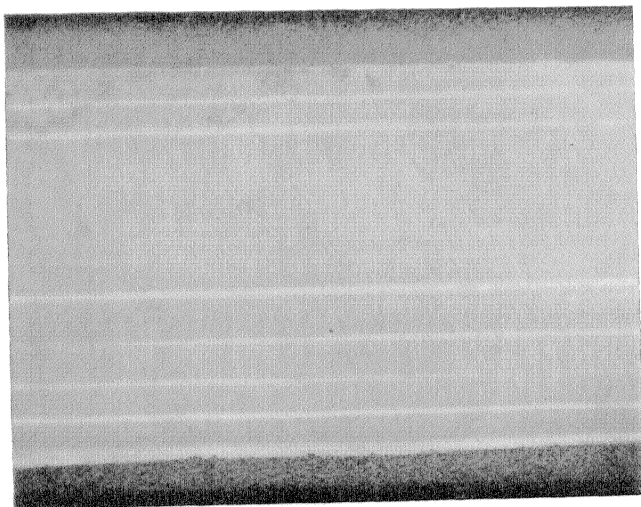
PHOTOGRAPH NO. 26.  
Light streaks in steel rail.

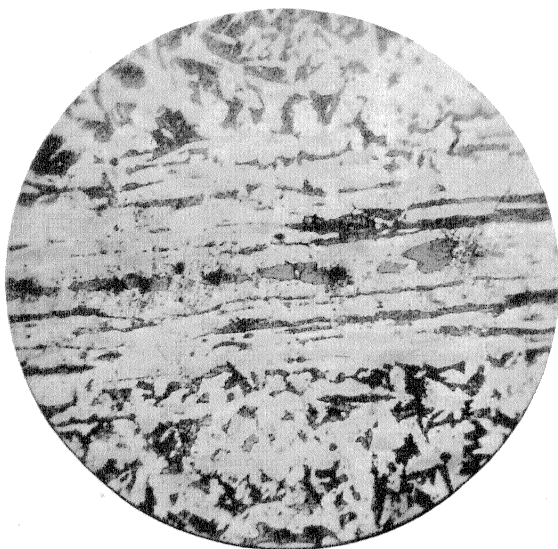
PHOTOGRAPH NO. 27. X50.

Microstructure of light-colored streak in No. 26.

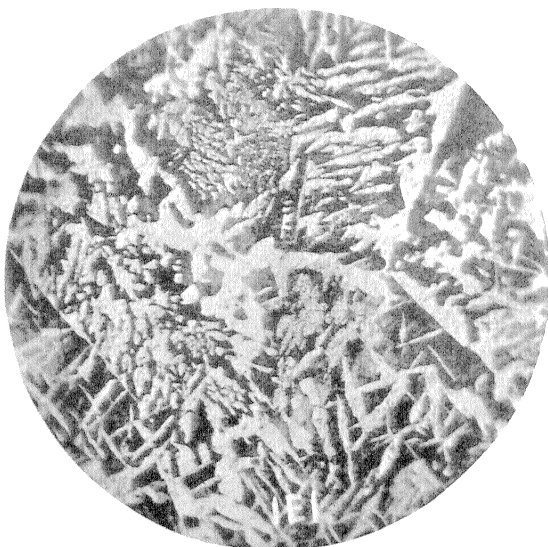
PHOTOGRAPH NO. 28. X75.

Microstructure of cast steel ingot as cast.

Elastic Limit	39,000
Tensile Strength	77,000
Elongation	10.5
Contraction of Area	16.9

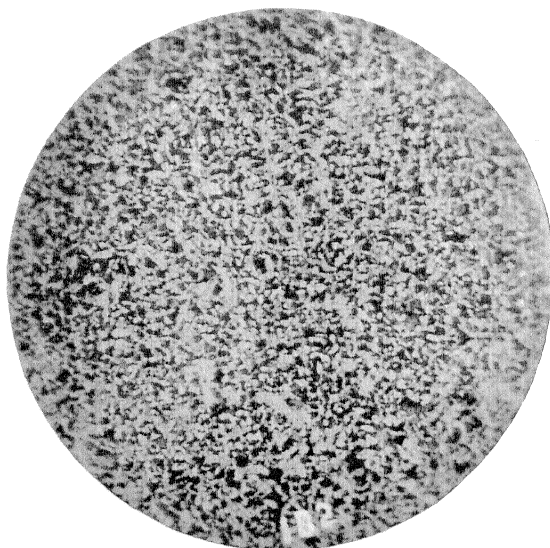
PHOTOGRAPH NO. 29. X75.

Microstructure of cast steel ingot forged to 1450° F. (788° C.)

Elastic Limit	50,500
Tensile Strength	83,500
Elongation	27.5
Contraction of Area	43.3

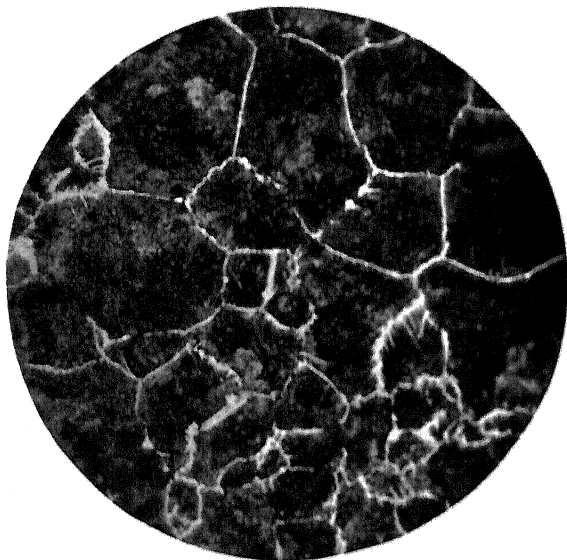
PHOTOGRAPH NO. 30. X75.  
Coarse microstructure in gun steel.

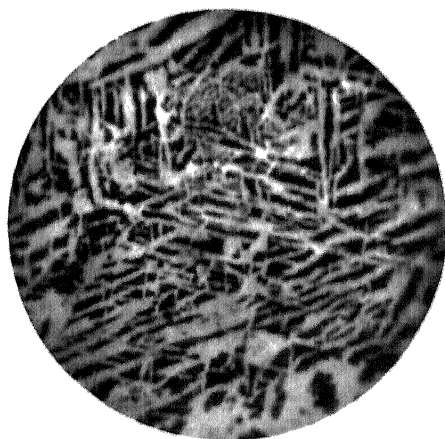
PHOTOGRAPH NO. 31. X50.  
Crystalline structure in cast steel.

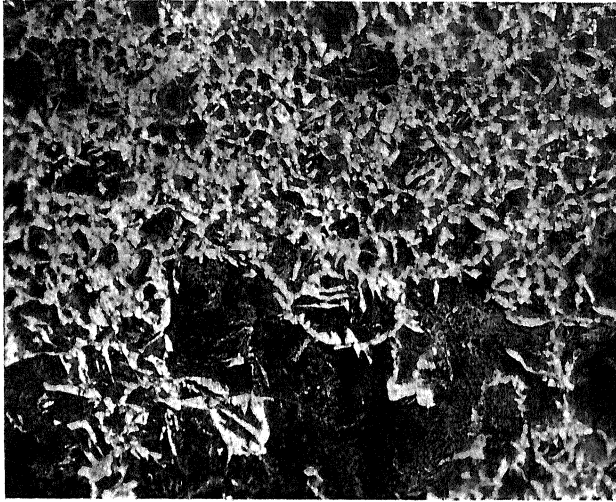
PHOTOGRAPH NO. 32. X75.

Microstructure showing incomplete heat treatment.

Failure to obtain uniformity of structure is shown in photograph No. 32. Discussion of photographs Nos. 49, 51, and 53 will be found under the discussion of some of the special cases, viz., the failure of 14-inch gun lever arm. Dangerous overheating is shown in photograph No. 33. In this case the material is burnt, as is shown by the oxide between the granules of pearlite.

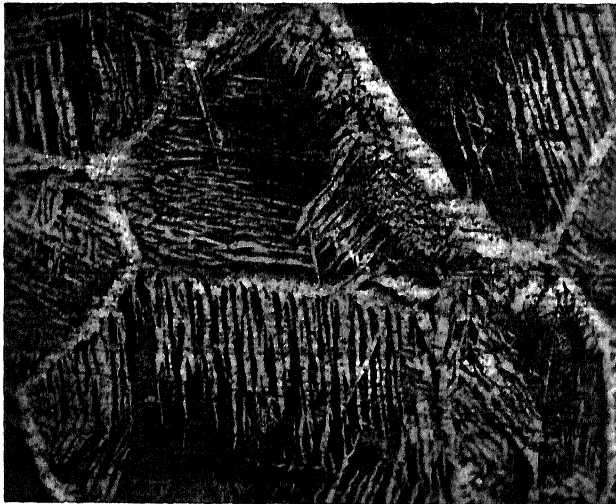
PHOTOGRAPH NO. 33. X75.

Microstructure of overheated steel.

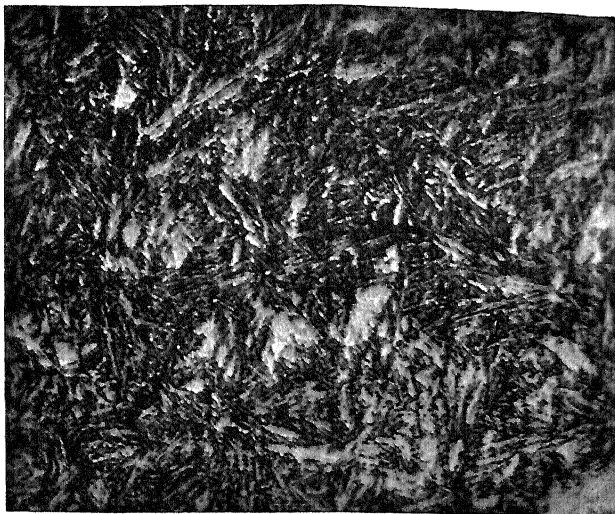
PHOTOGRAPH NO. 34. X500.

Microstructure of forging which had been originally martensitic, and in tempering this structure has not been completely eliminated.

observed that the original martensitic structure is completely removed by the tempering process. This point is illustrated by photograph No. 34 in which there are distinct remains of the original martensitic structure. Such a steel properly heat treated ought to show a structure similar to photographs Nos. 12 or 13.

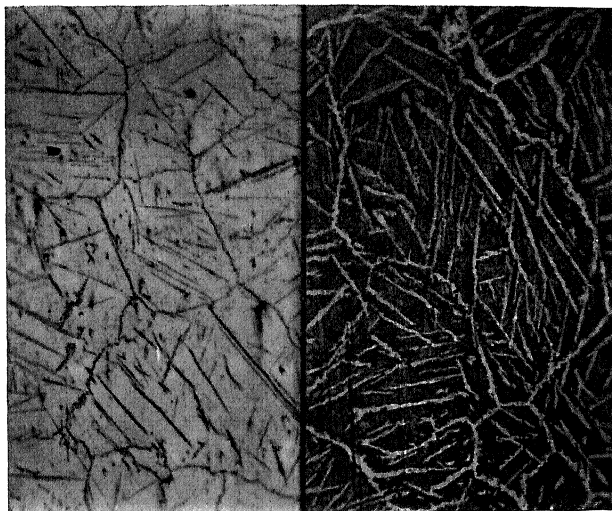
PHOTOGRAPH NO. 35. X65.

Microstructure in center of broken recoil spring showing excess cementite, indicating high carbon. Left, white lines are cementite etched with nitric acid solution; right, dark lines are cementite etched with sodium picrate solution.

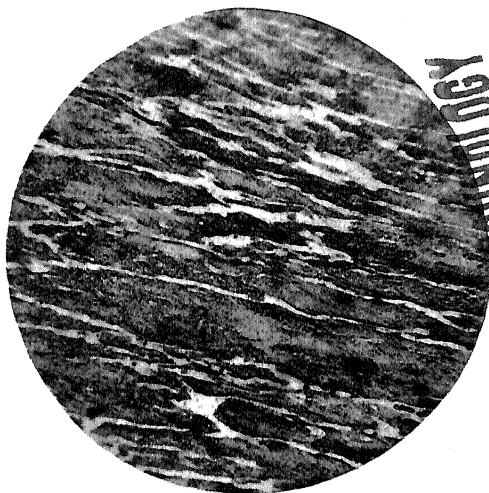
PHOTOGRAPH NO. 36. X50.

Microstructure of steel subjected to cold work, and  
showing distortion of grain.

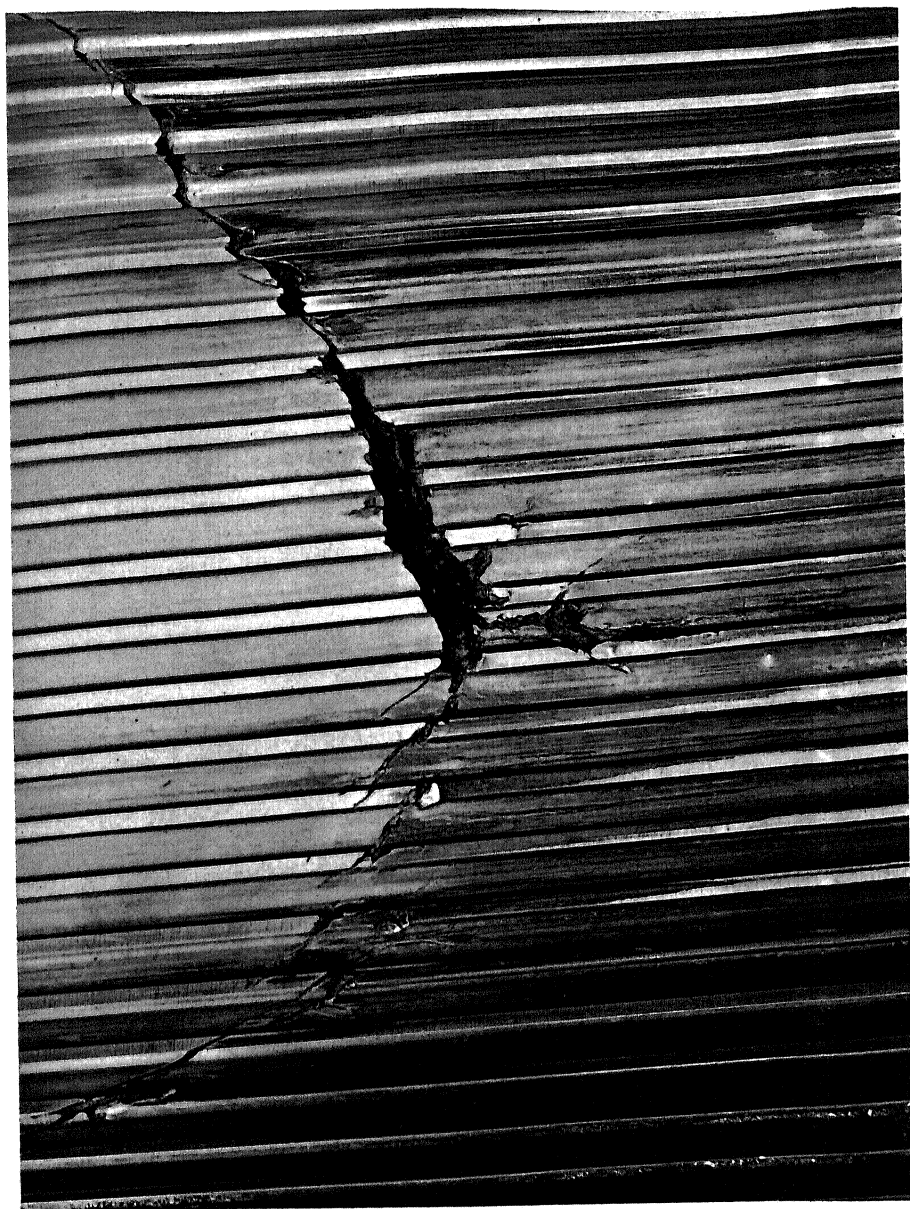
PHOTOGRAPH NO. 37.  
Crack in 10-inch rifle.

The tube of this gun was found to be cracked after proof-firing. The crack was situated about 2 feet in from the breech end and extended in the form of a crescent through a visible distance of about 10 inches. At the central portion of the crack the walls were considerably more separated than at either end, and considerable metal had been removed at this point. The general appearance is shown in photograph No. 37. It will be noted that the crack is not continuous.

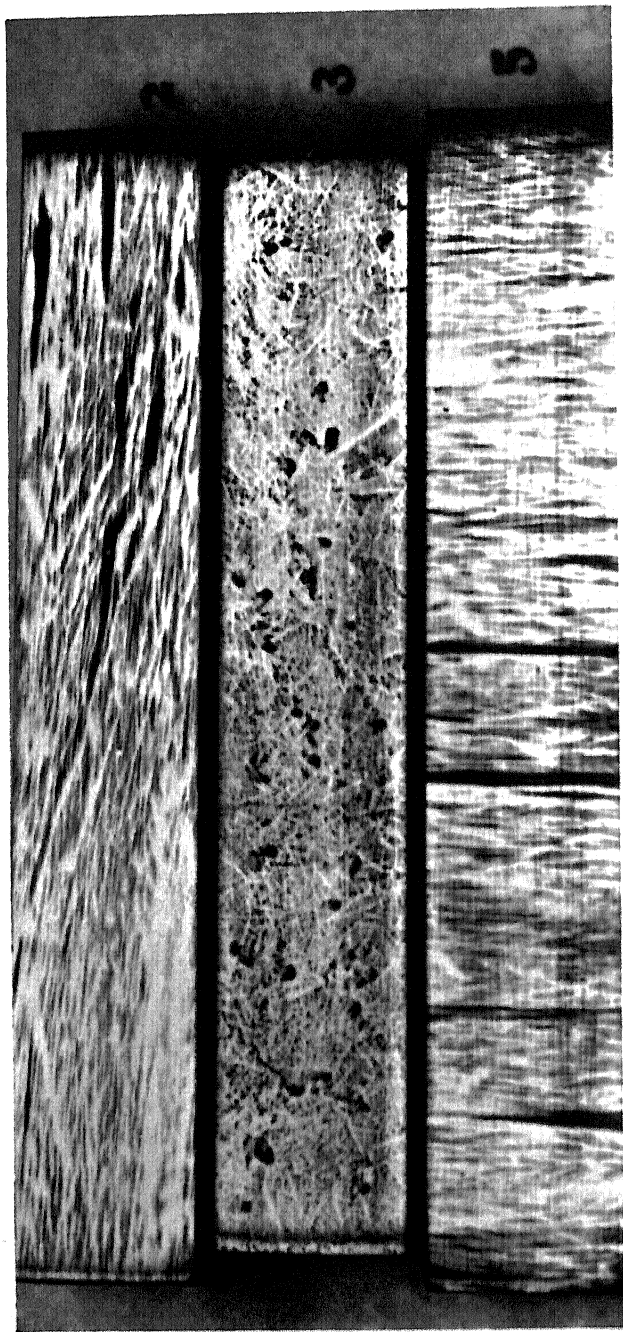
PHOTOGRAPH NO. 38.

Macrostructure of test bars of 10-inch rifle, showing surfaces cut longitudinal 5, radial 3, and tangential 2 to axis.

Photographs Nos. 38 and 39 show the macrostructure of this steel when etched with iodine, the specimens shown in photograph No. 38 being taken longitudinally, radially, and tangentially. The segregation of phosphorus is indicated by the dark lines in pieces Nos. 2 and 5 of photograph No. 38 and in both pieces of photograph No. 39 and by the dark spots in piece No. 3. Photograph No. 39 shows the metal cut from the region of the fracture and treated in the same manner, as shown in test piece marked 5 in photograph No. 38, and in other test pieces not shown. The dark streaks were found to be elongated parallel to the direction of forging, and it is reasonable to suppose that the elongation will always be parallel to the surfaces being forged. By inspection of the two larger pieces of metal cut from the region of the crack (photograph No. 39) it will be seen that there is considerable distortion of the phosphide areas near the

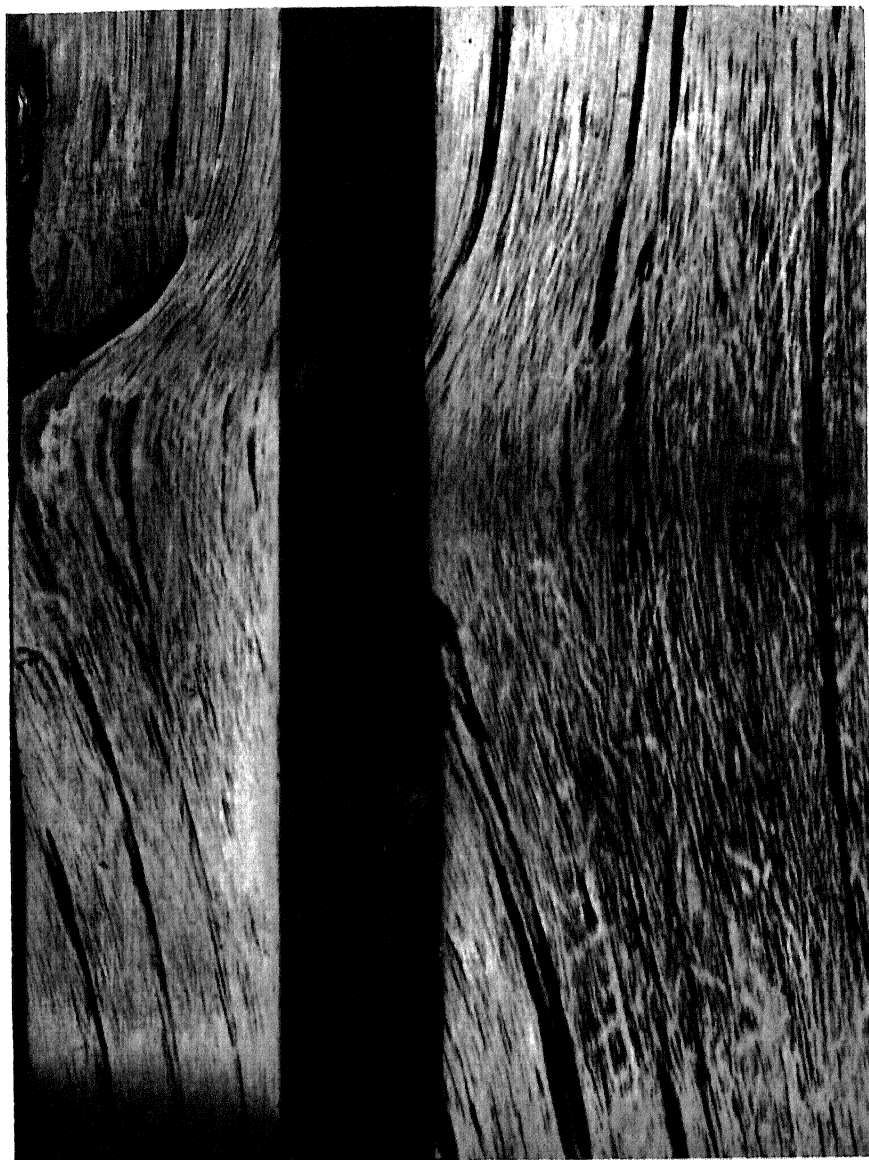
PHOTOGRAPH NO. 39.

Macrostructure in region of crack in 10-inch rifle.

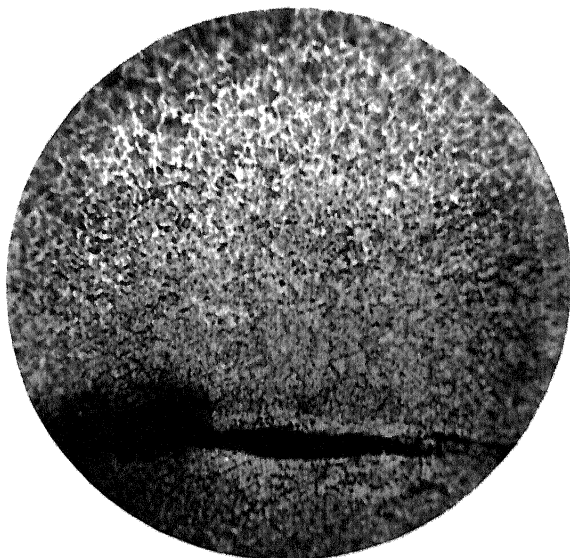
PHOTOGRAPH NO. 40. X50.

Crack and slag, with decarbonized area in 10-inch rifle.

Examination of sections in the vicinity of the crack showed many fine cracks, slag inclusions, and carbonless areas. The cracks led to slag, and where the slag was found there were also found decarbonized areas. Photograph No. 40 shows a crack ending in slag and surrounded by decarbonized iron. The course of the slag was quite irregular, as shown in photographs Nos. 41 and 42.

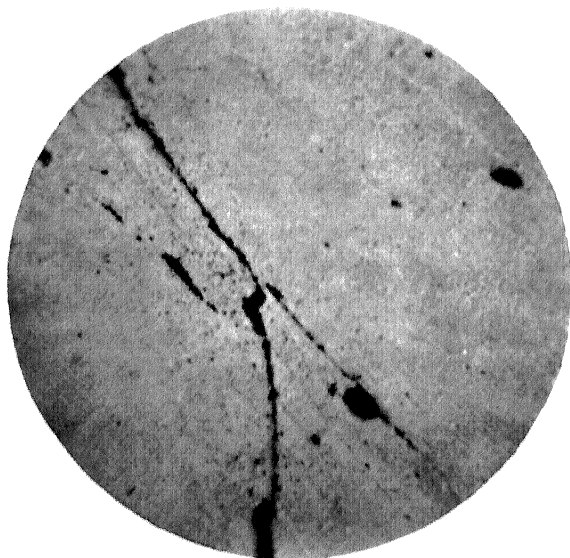
PHOTOGRAPH NO. 41. X50.

Slag in 10-inch rifle, unetched.

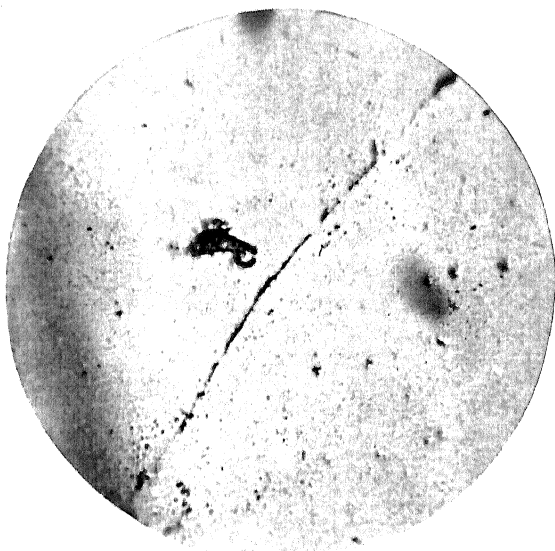
PHOTOGRAPH NO. 42. X50.

Slag in 10-inch rifle, unetched.

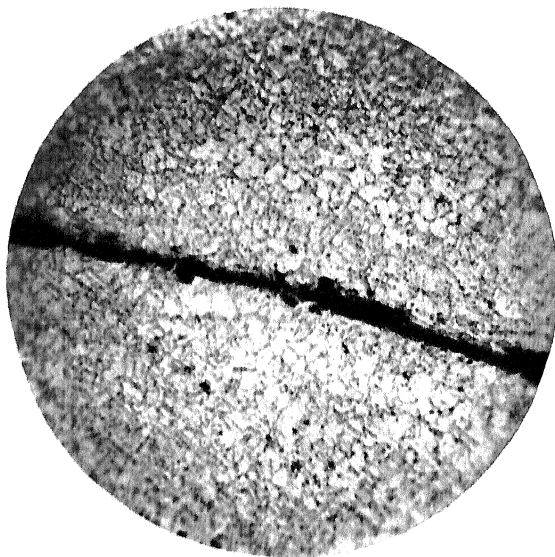
PHOTOGRAPH NO. 43. X50.

Slag and decarbonized area in 10-inch rifle.

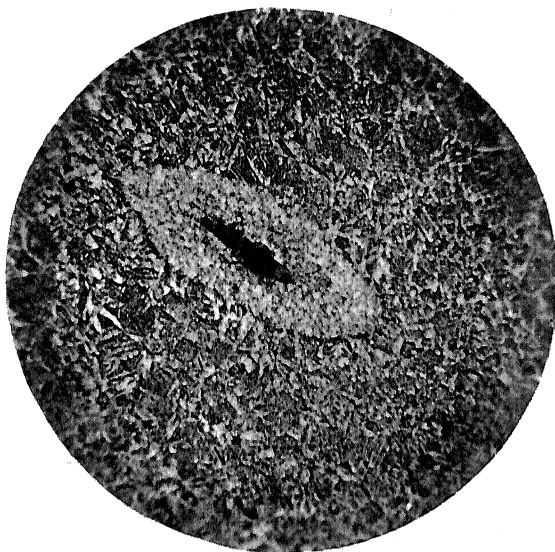
PHOTOGRAPH NO. 44. X50.

Island of slag in decarbonized area in 10-inch rifle.

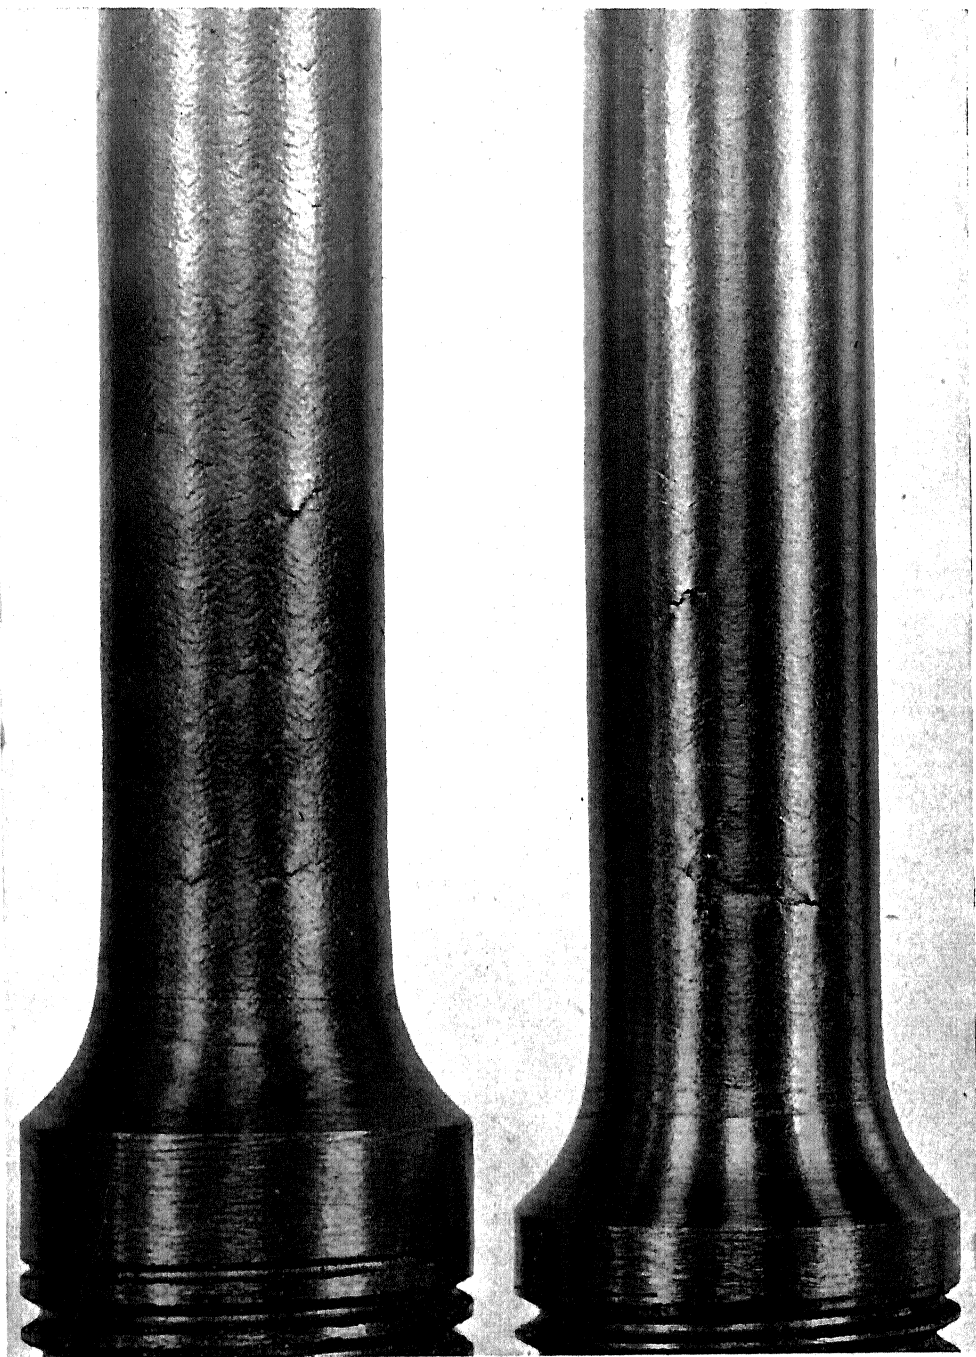
PHOTOGRAPH NO. 45.

Fourteen-inch gun lever test bar specimens showing incipient cracks.

In the fractured ends of the test pieces the metal shows decidedly bright spots, and these are due, it is believed, to the presence of the segregated ferrite. Further, it has been noticed that along the stem of the test pieces incipient cracks are developed, as shown in photograph No. 45. It is highly probable that these incipient fractures are developed in such areas as shown in photograph No. 47, which shows a large ferrite field at the edge of the specimen. It is possible that if the forces are transmitted equally throughout the test piece that such a portion would yield more readily where the carbon was lowest. The strength of such a spot would be approximately that of pure iron, or about 40,000 pounds per square inch, while the darker areas which contain more carbon would show considerably higher values. The presence of much slag in the ferrite areas would also increase the brittleness at this point, and would account for the low ductility in some specimens. Further examples of this form of segregation are shown in photographs Nos. 48 and 49.

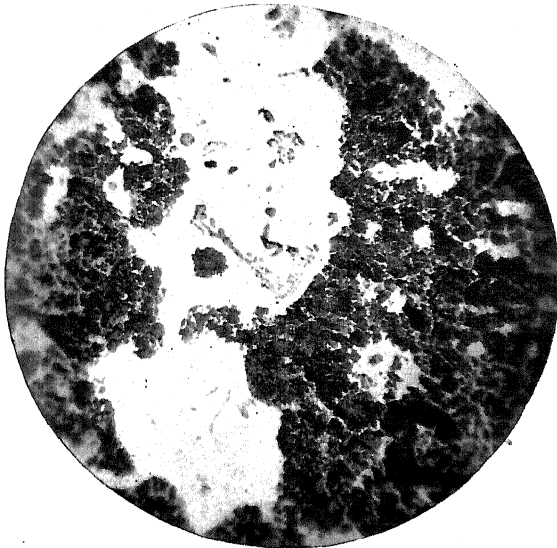
PHOTOGRAPH NO. 46. X50.

Fourteen-inch gun lever. Segregated ferrite (white) with slag inclosures.

This lever was made of cast steel and was broken during the test of the carriage. A microscopic examination revealed the structures shown in photographs Nos. 46 to 51, inclusive.

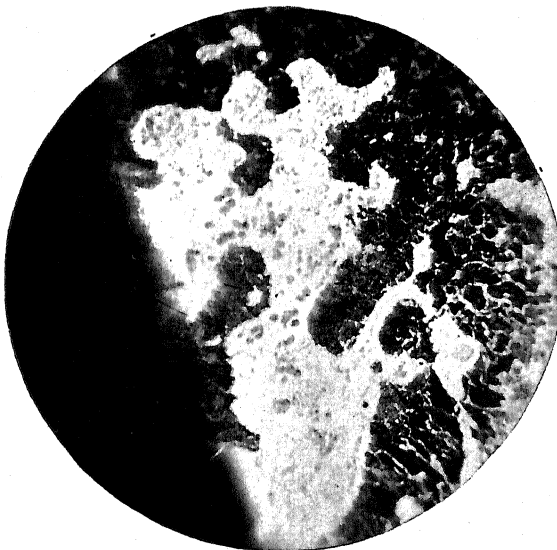
PHOTOGRAPH NO. 47. X50.

Fourteen-inch gun lever. Segregated ferrite on edge of test piece. Slag inclusions.
